**WEST VIRGINIA DEPARTMENT OF ENVIRONMENTAL PROTECTION  
WV OIL AND GAS CONSTRUCTION STORMWATER PERMIT**

<b>FACILITY NAME:</b>	Mountain Valley Pipeline Project			<b>REG. #</b>	<b>EXPIRE DATE:</b>
<b>PERMITTEE</b>	MOUNTAIN VALLEY PIPELINE, LLC			WVR310667	12/1/2020
<b>ADDRESS/PHONE:</b>	Attn: MATTHEW HOOVER 625 LIBERTY AVE, ST 1700 PITTSBURG, PA 15222 (724)873-3645				
<b>LOCATION:</b>	Spread F MP 171 approx.			<b>Entry Date/Time:</b>	8-13-2019 @ 13:45
<b>COUNTY:</b>	Summers			<b>Exit Date/Time:</b>	8-13-2019 @ 15:00
<b>Site Representative /Phone</b>	Percy Jones, EI Spread F, MVP 601 513-7667 R.J. Ballew, Envir. w/ Trinity Energy 817 999-4523 Damon Bowers, Chief Inspector, Spread F			<b>PHOTOS</b> <input checked="" type="checkbox"/>	
<b>CO-PERMITTEE:</b>				<b>ADDRESS:</b>	
<b>SITE OPERATOR:</b>	Trinity Energy Services			<b>ADDRESS:</b>	200 Highland Cr. Argyle TX 76226
<b>PERMITTED ACREAGE</b>	4311	<b>WEATHER:</b>	Sunny	<b>LAST INSPECTION:</b>	N/A
<b>RECEIVING STREAM(S)</b>	UNT/Greenbrier Rv/New Rv/Kanawha Rv				<b>NOV: 0</b>

**PERMIT / SITE EVALUATION**

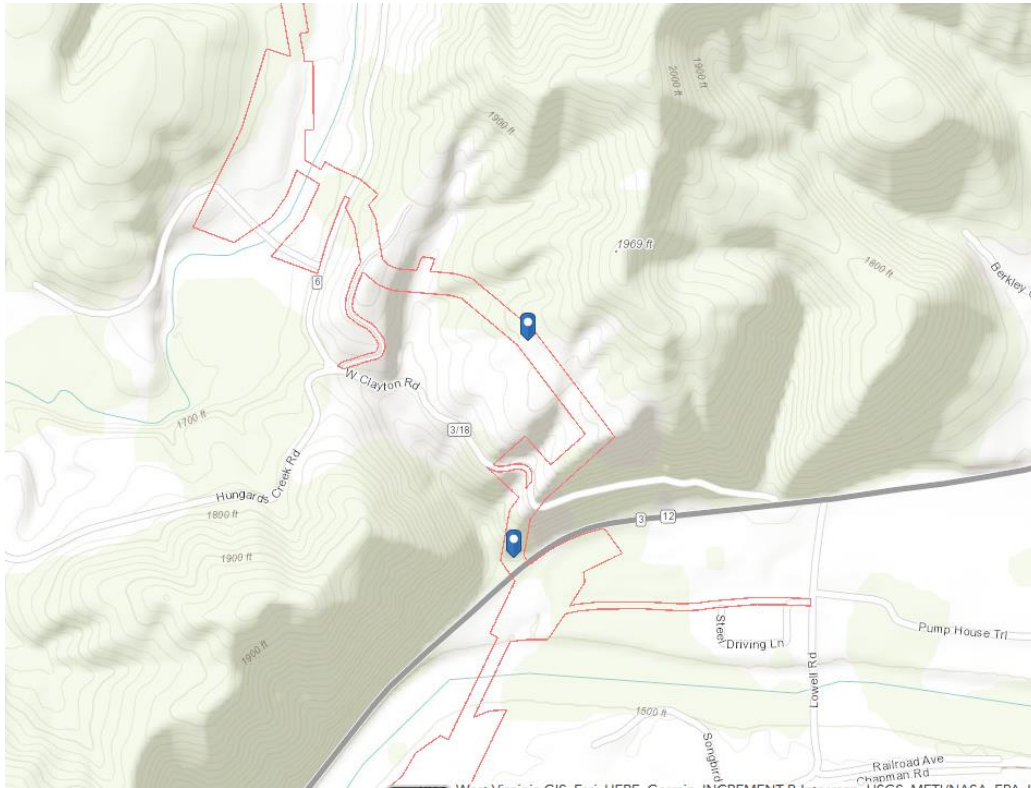
Area of ROW inspected is between blue markers.

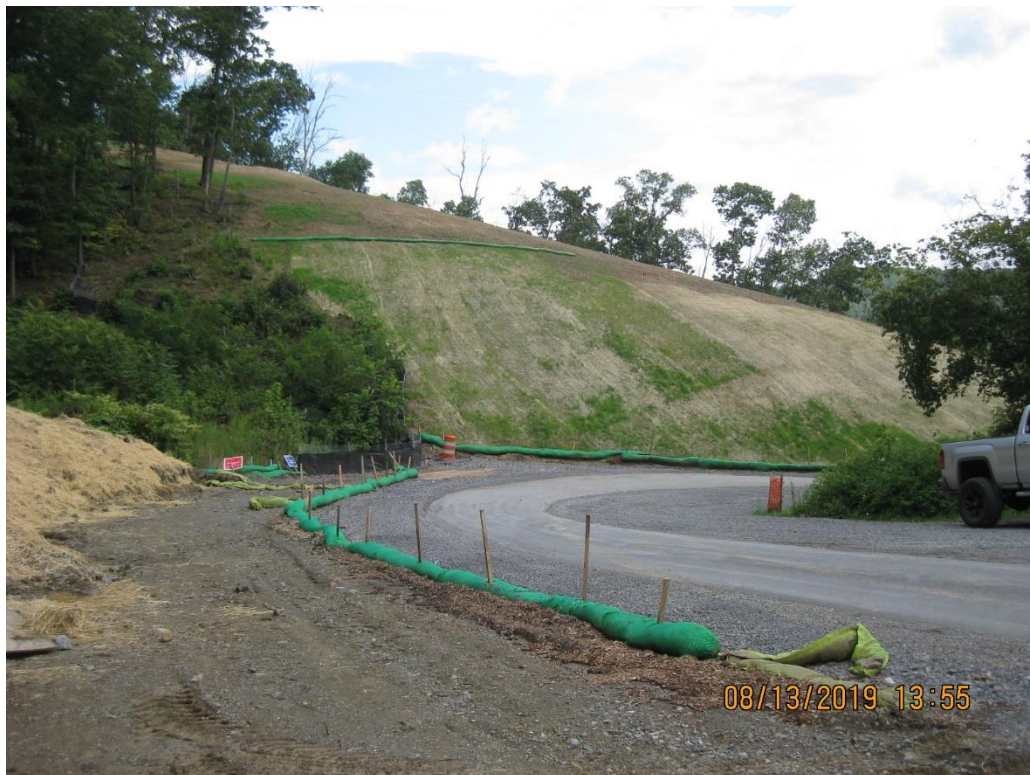
ROW crossing West Clayton Road. Matting, seed and mulch applied at final grade.

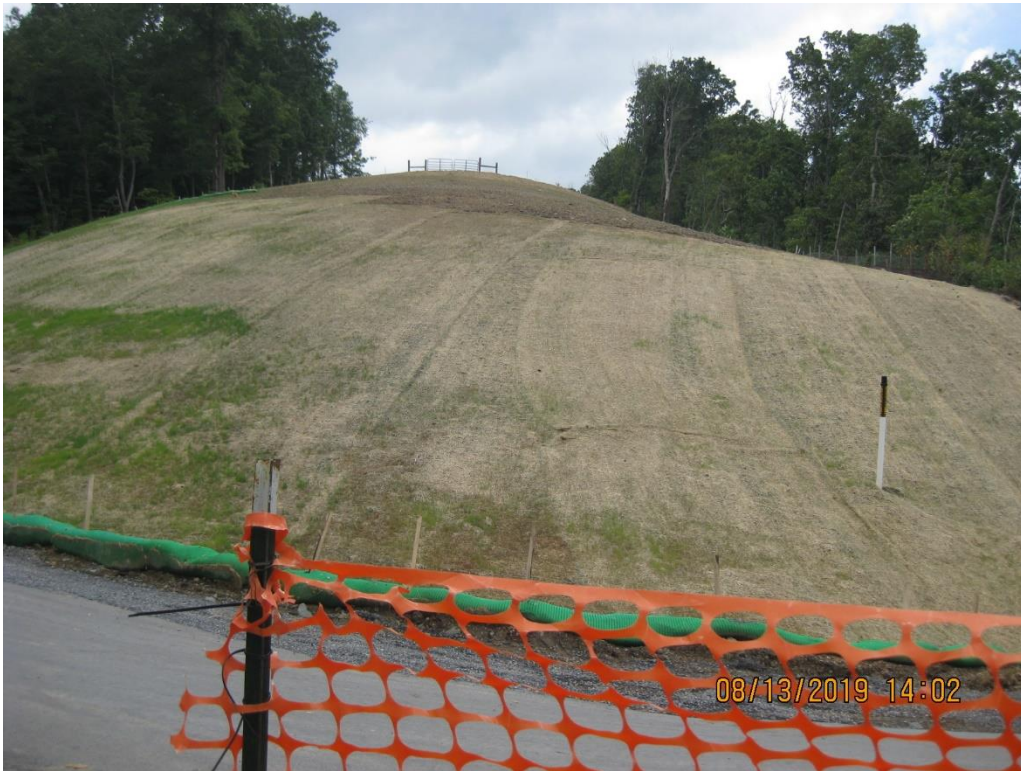
ROW crossing West Clayton Road. Matting, seed and mulch applied at final grade.

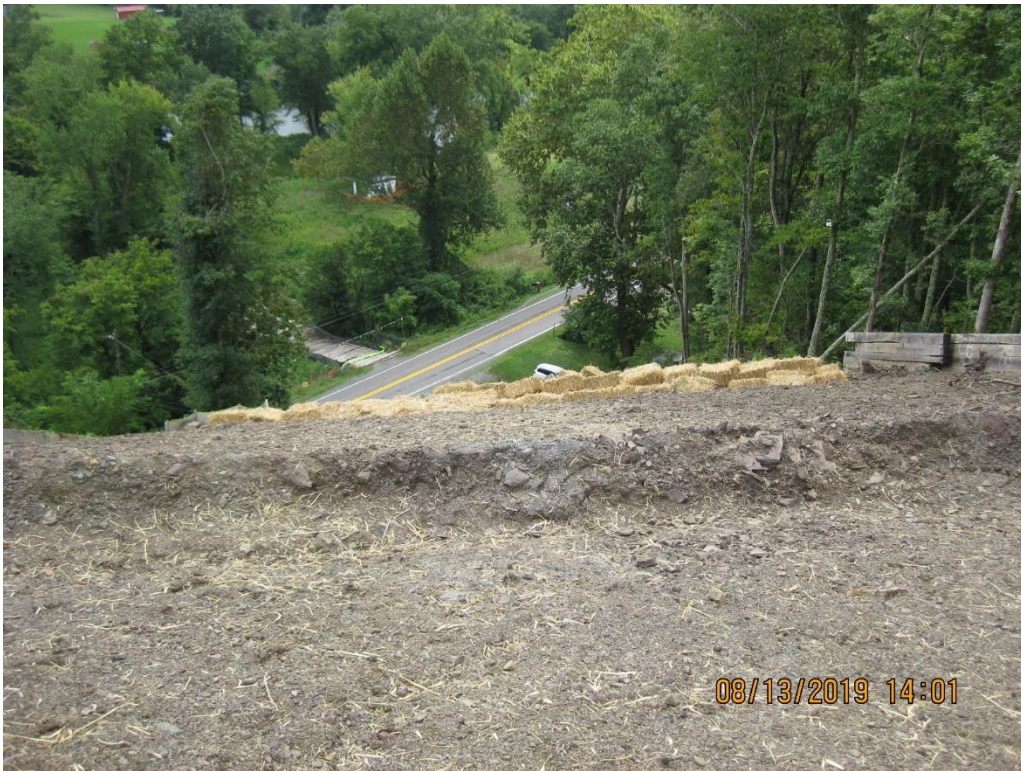
Hand seeding/mulching were ongoing during the inspection on a steep slope adjacent to the greenbrier river/ Rt. 12 crossing. Bales pictured were stockpiled for this purpose.

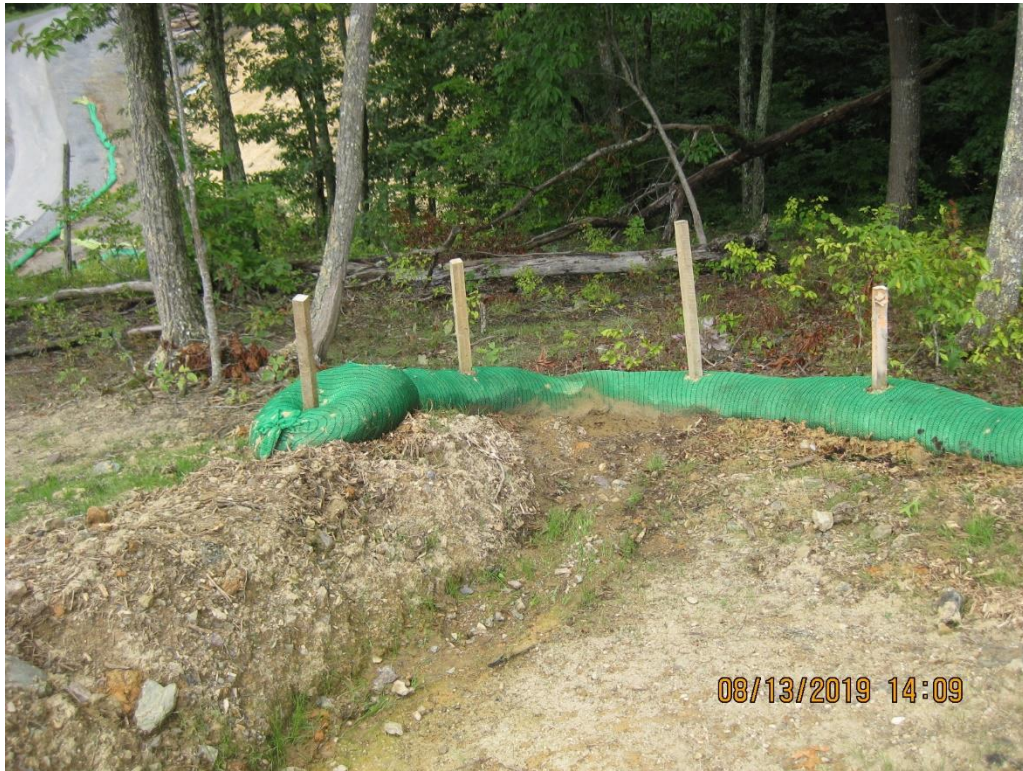
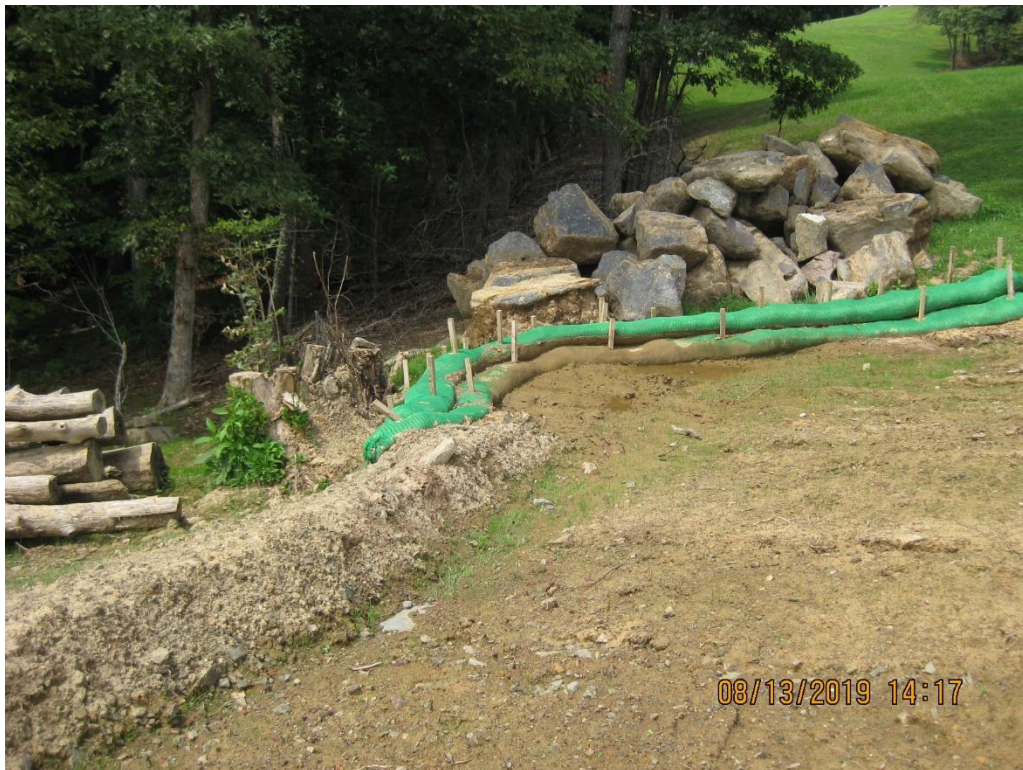
- (1.) Perimeter controls were in place as needed. Some small, upland, sheet flow drainage areas that had received hydroseeding did not have perimeter controls in place and showed no evidence of sediment laden water leaving the site.
- (6. 7. 13.) Sumps of waterbars between St. 9050 and St. 9037 appeared to have performed properly, they all had discharged into vegetation buffers with little to no deposits present in the discharge path. Enhancements for one sump and minor maintenance were recommended during discussions with permittee representatives.

Sumps of waterbars between St. 9050 and St. 9037 appeared to have performed properly. They all had discharged into vegetation buffers with little to no deposits present in the discharge path.

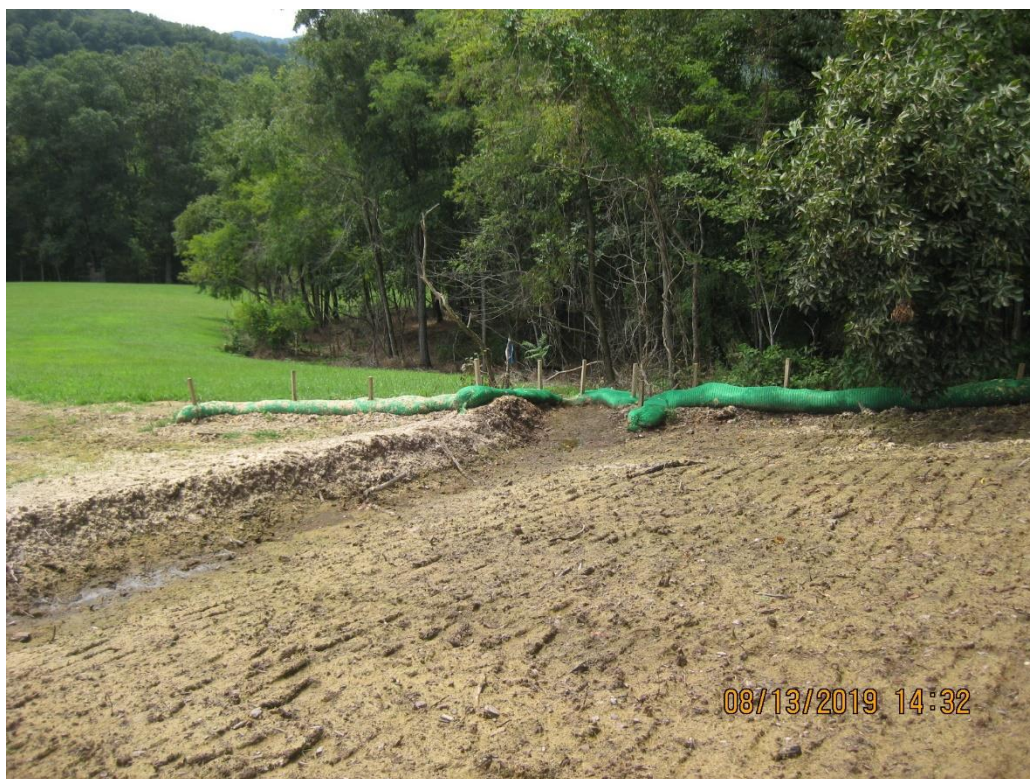
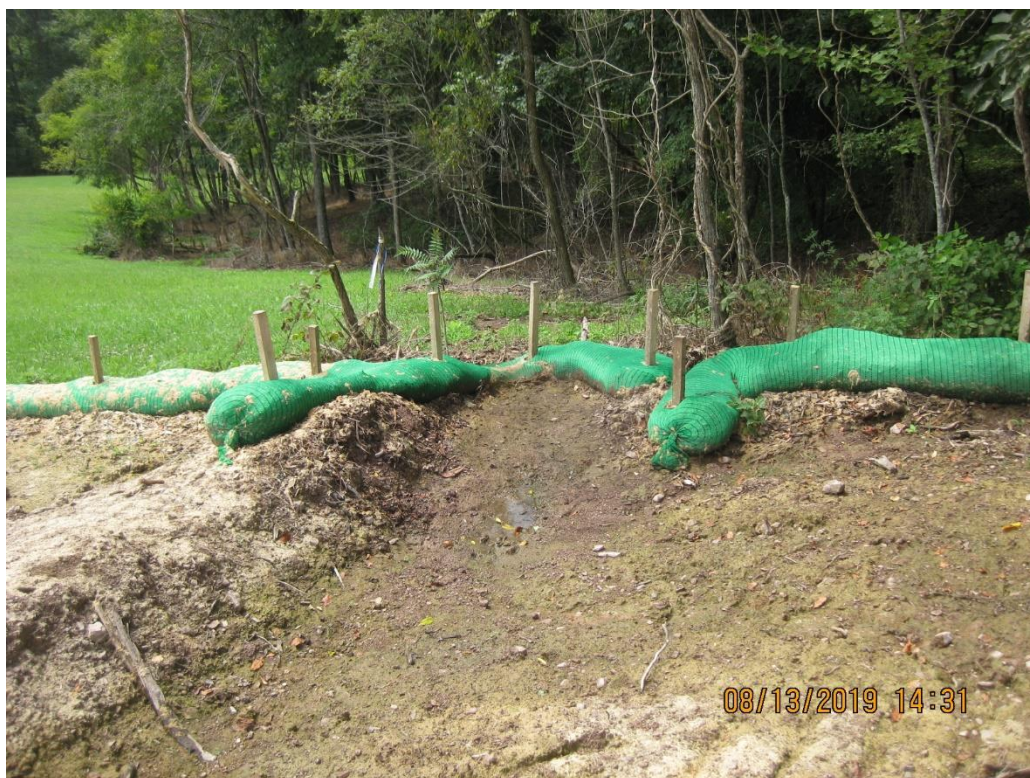
Sumps of waterbars between St. 9050 and St. 9037 appeared to have performed properly. They all had discharged into vegetation buffers with little to no deposits present in the discharge path.

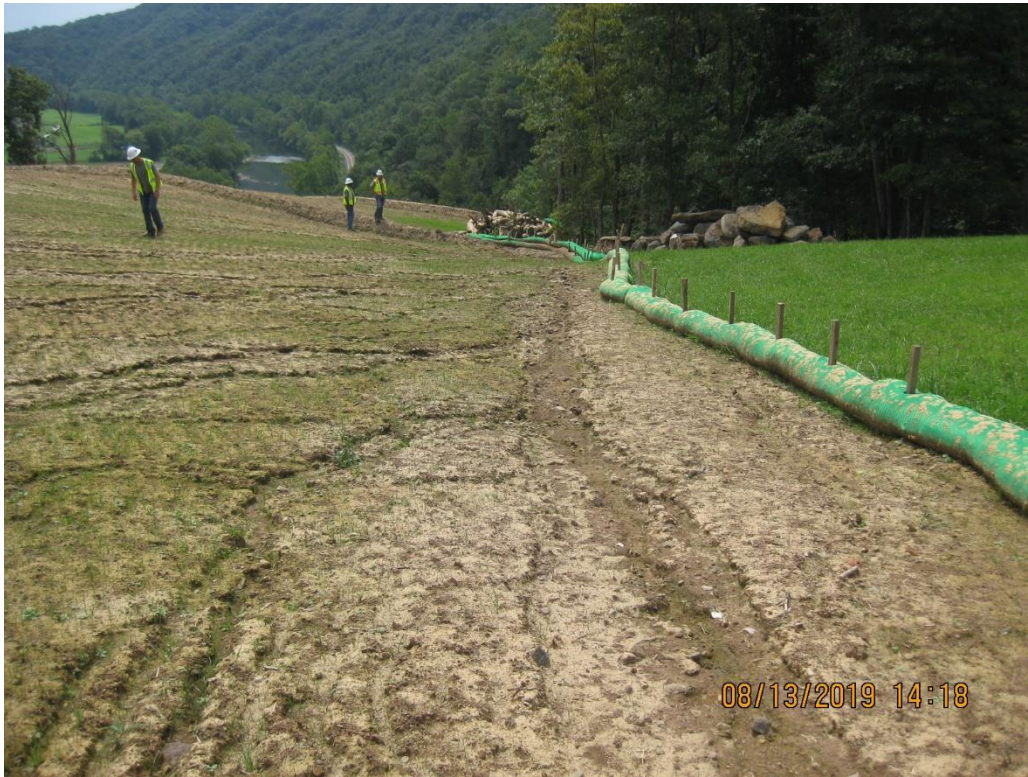
One set of rills had developed leading to a sump at St. 9045. It was recommended to establish an interceptor diversion with a series of additional catchment (checks/sumps) to reduce pressure on the final control until vegetation is established.

3. (14.) One set of rills had developed leading to a sump at St. 9045. It was recommended to establish an interceptor diversion with a series of additional catchment (checks/sumps) to reduce pressure on the final control until vegetation is established.

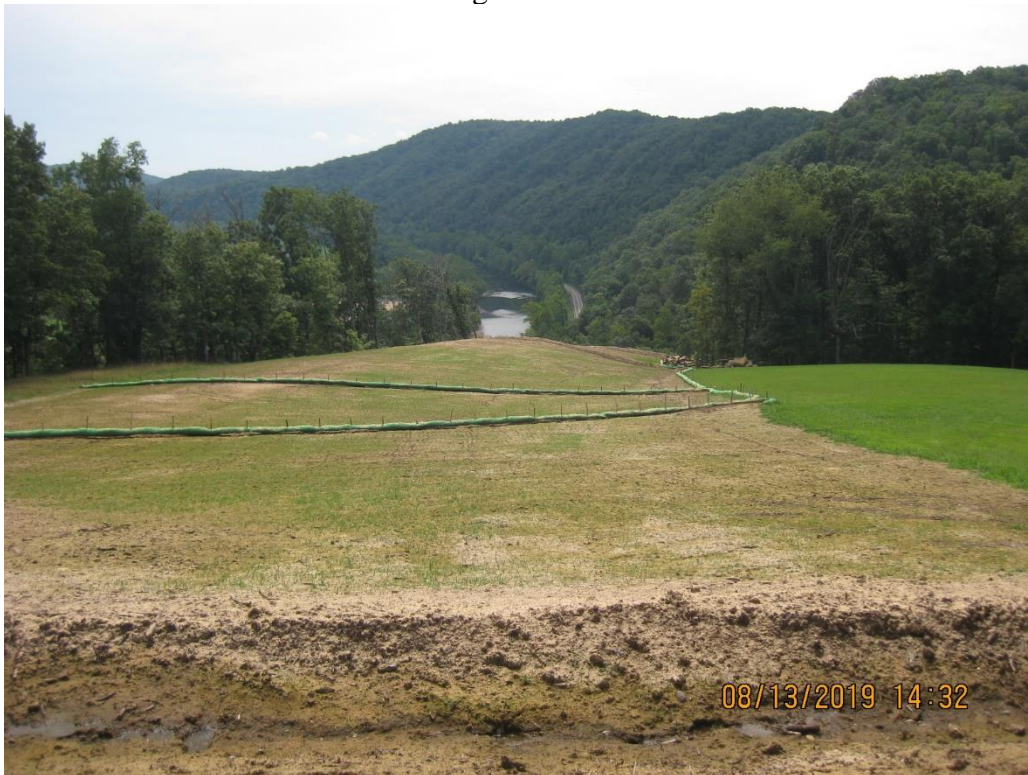
Pipe has been installed, the area was at final grade and stabilization measures have been initiated.

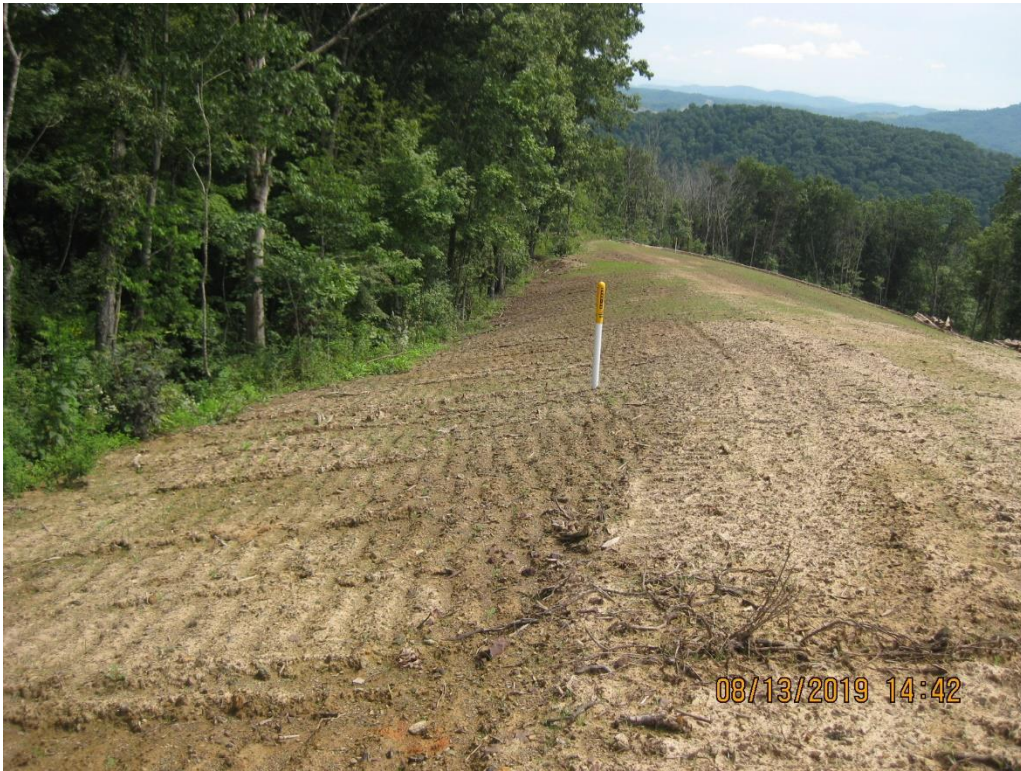
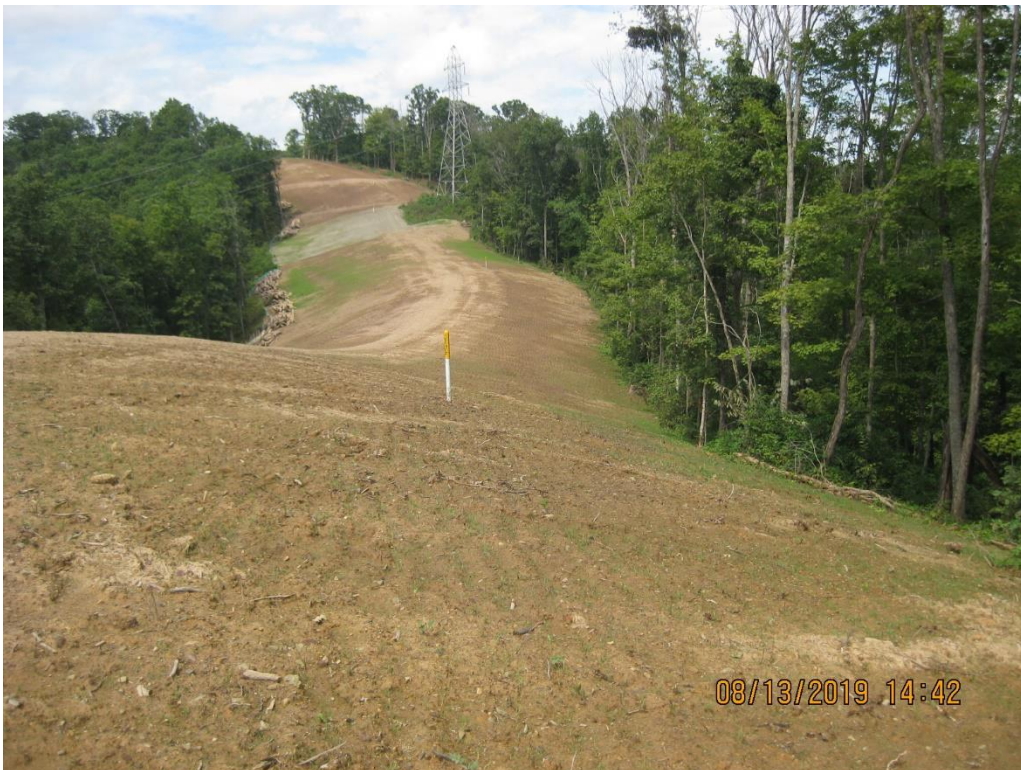
Some small, upland, sheet flow drainage areas that had received hydroseeding did not have perimeter controls in place and showed no evidence of sediment laden water leaving the site.
